# St Mary's Church, The Street, Frittenden, Kent.

## Archaeological Watching Brief Summary Report

Project Code: WB SMCF17  
Planning Ref: N/A  
NGR: TQ 81319 40944 (centred)  
CAT Ref: 4174

August 2018

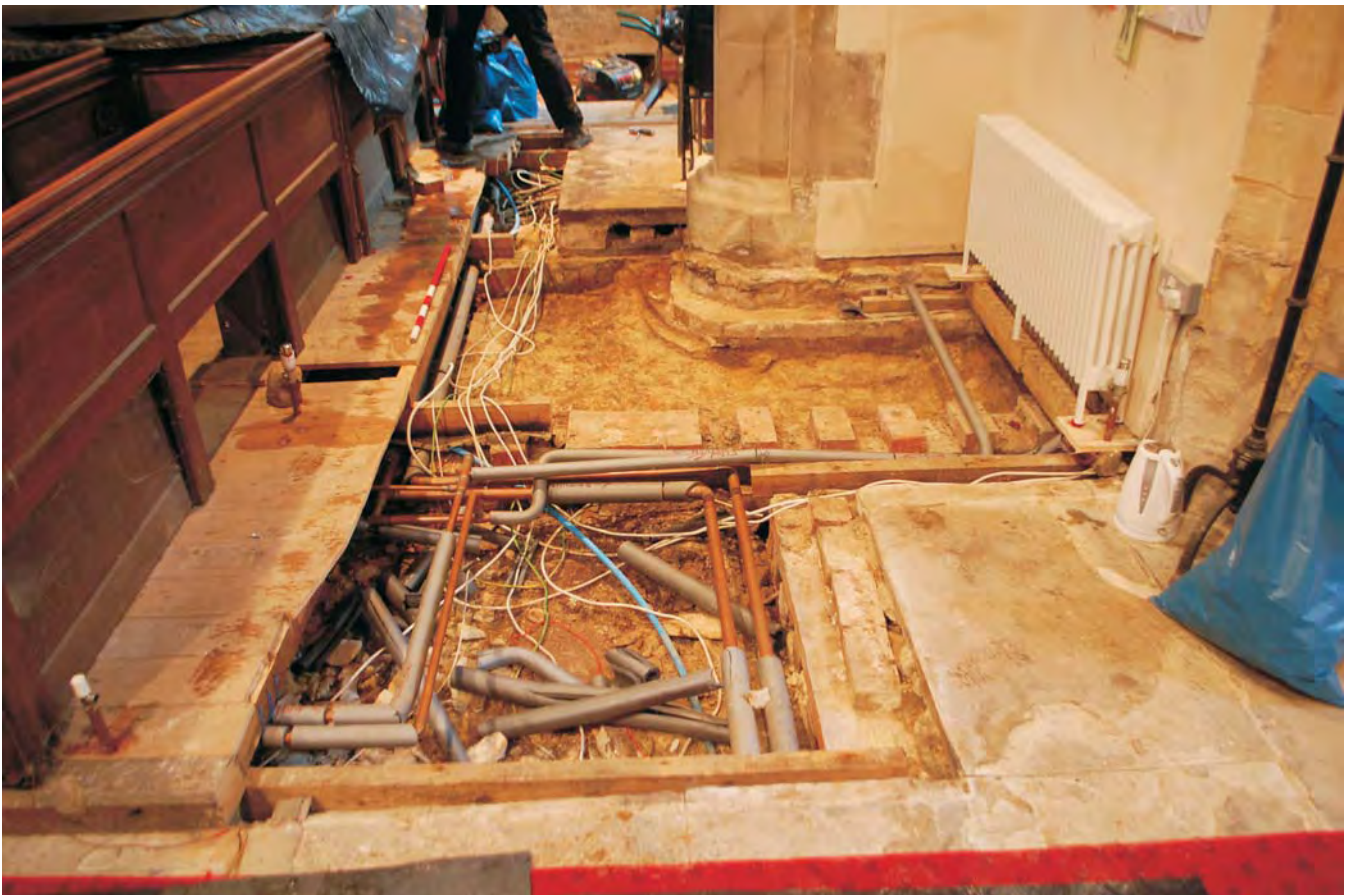
roughly square, masonry foundation extending eastward from the nave's west wall. Measuring roughly 2.2m (east – west) by 2.1m (north – south), the foundation was composed of small – medium irregular pieces of Ragstone rubble bonded with pale creamy grey coarse lime mortar containing small angular flint and Ragstone inclusions throughout. With a roughly level surface approximately 460mm below the former timber floor level, its outer limits were abruptly defined with faced stonework, whilst its northeast and southeast corners were formed of roughly hewn rectangular ashlar Ragstone blocks. Rising from the centre of this foundation's western side, projecting eastwards from the nave wall face, was a further section of raised masonry foundation measuring approximately 1.2m square. Constructed in a similar fashion to that beneath, this section of foundation, the upper surface of which was encountered at a depth of 390mm below the former timber pew floor, clearly formed an integral step in the upper surface to the lower foundation upon which the base of the pier respond would have originally been bonded to.

Plate 7. Interior view of St Mary's Church, Frittenden looking across Area A following the removal of the pews and timber flooring revealing the masonry foundation to the pier respond beneath (*note: brick dwarf walls to support timber pew floor*).

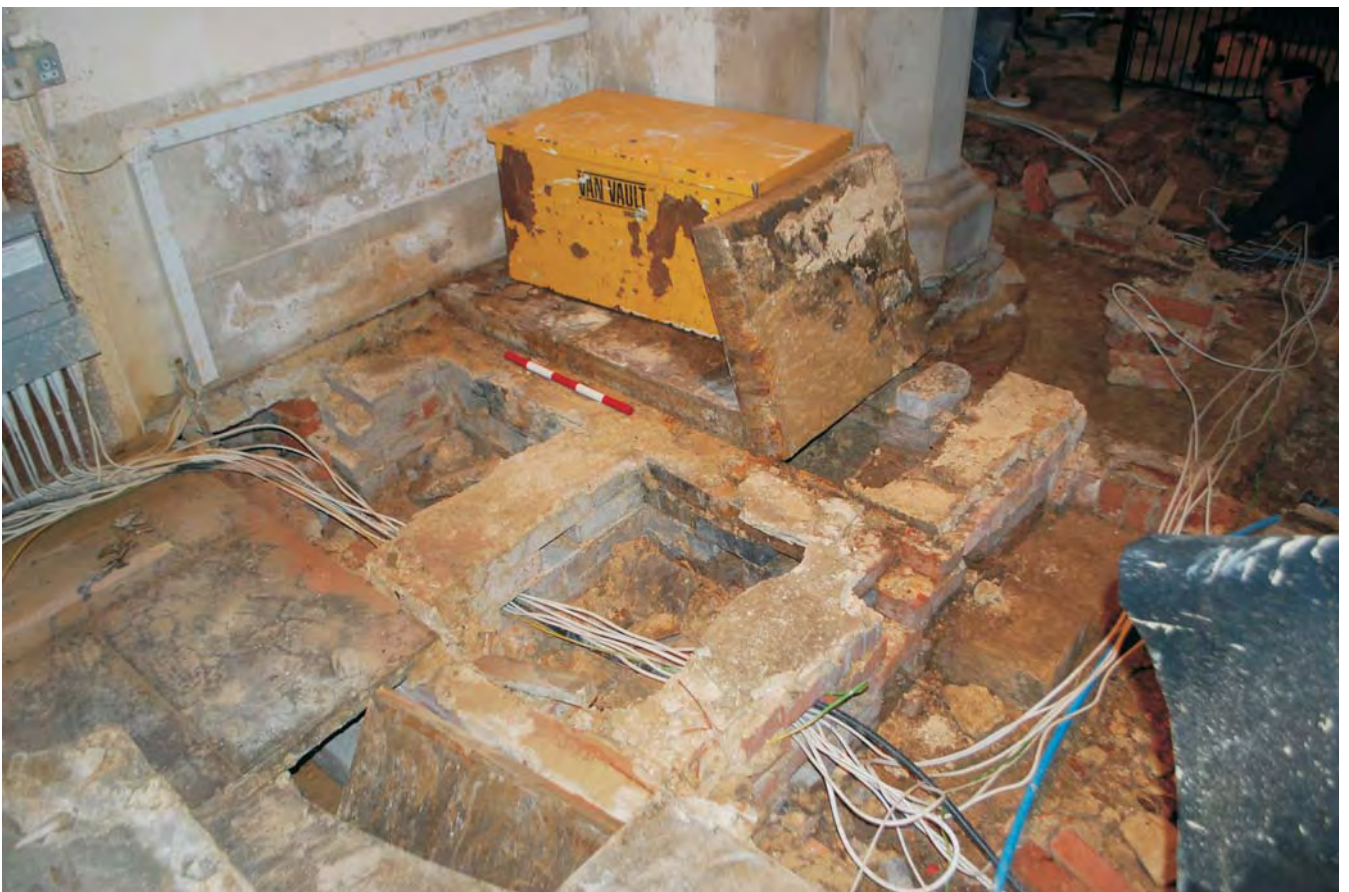
This was subsequently sealed by a series of linear dwarf walls formed of unfrogged red Kentish stock bricks bonded with similar coarse, gritty lime mortar observed sealing the base

of the ground reduced area. Initially forming a series of three east – west aligned parallel lengths of walling, one each along the north and south sides of the pew floor area and one through the centre all to provide end and mid support to a series of perpendicular aligned timber joist aligned north – south.

Consisting of only three brick courses tall (240mm) and one brick length wide (220mm), each section of dwarf walling was constructed with a regular series of through-holes to enable the movement of air beneath the timber floor. However, this simple dwarf wall arrangement immediately adjacent the pier responds southern side, where a further succession of shorter brick dwarf walls with through-holes were inserted, together forming a series of smaller roughly rectangular compartments. Some of these dwarf wall lengths were noted as extending across the upper surface of the masonry pier respond foundation as single brick courses, all of which were installed to provide support to an arrangement of square Yorkstone slabs possibly associated with the position of a heating stove. Between each brick dwarf wall, sealing the upper surface of the possible construction trampled mortar surface was a roughly 60mm thick deposit of mid – dark greyish brown loose sandy, gritty soil and dust containing numerous small pieces of discarded Ragstone chippings, broken lime mortar lumps and occasional broken ceramic roof tile fragments. This also included other more recent discarded material such as small timber off-cuts and clippings from electrical cables, presumably associated with the later installation of modern services? This contrasted with the remainder of the pew floor area, which was floored in softwood floorboards across which the pew benches were jointed.

Plate 8. Interior view of St Mary's Church, Frittenden looking across Area A following the removal of the pews and timber flooring revealing the brick dwarf walls supporting the stone slab floor overlying the masonry foundation to the pier respond (*note: excessive brick support walls possibly to support internal stove?*).

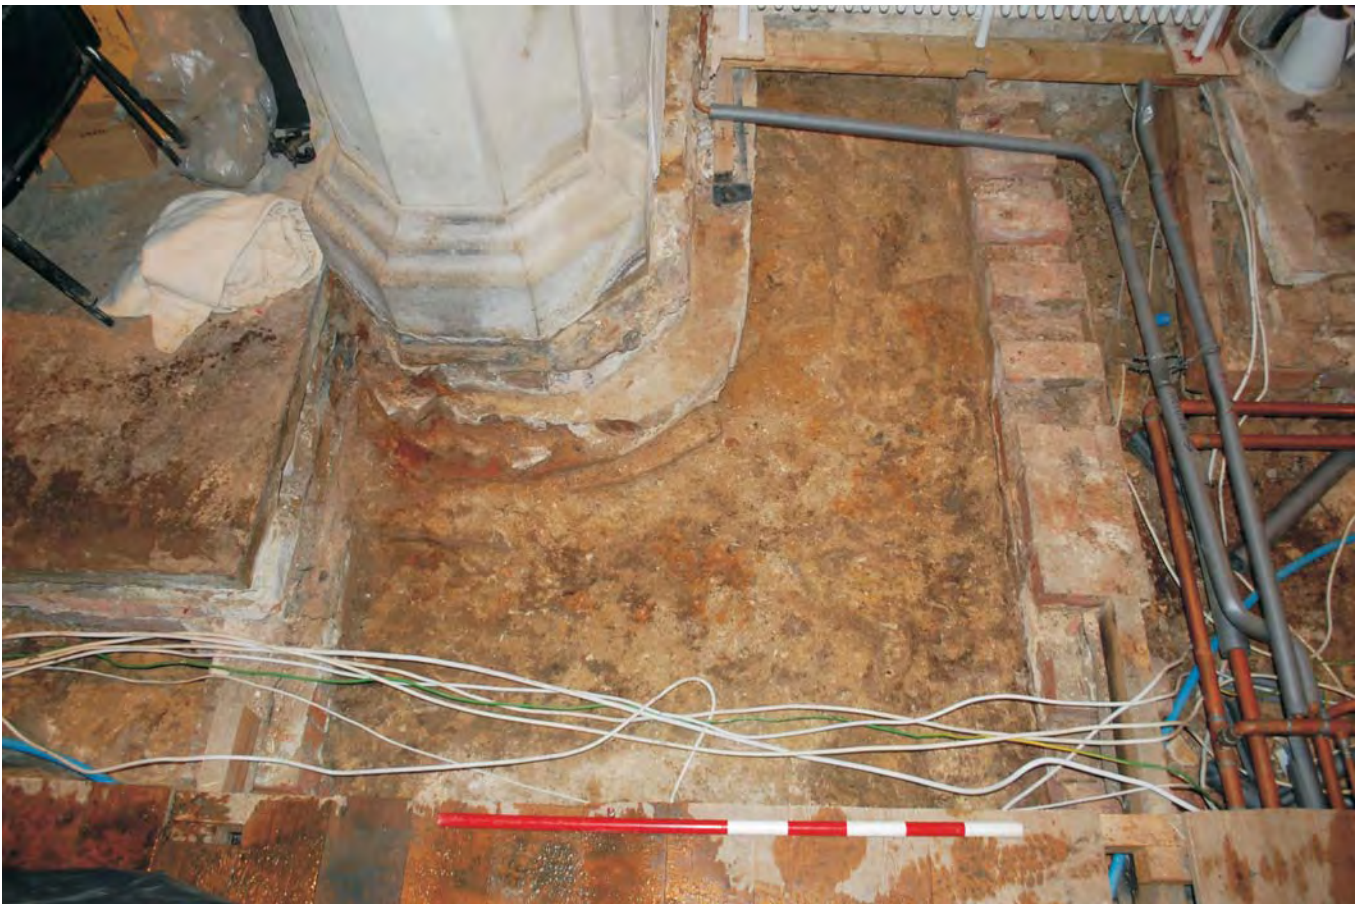
It is almost certain that the exposed foundation beneath the pier respond and the section of wall foundation adjacent all relate to the construction of the tower; the section of wall foundation being the remnants of the earlier west wall of the medieval south aisle and the eastern face of the tower's southeast buttress. Unfortunately, only limited exposure of the wall foundation due to existing plaster wall covering meant that a direct relationship of this junction could not be fully seen. However, the pier respond base appeared to have been further affected during the rearrangement of the south aisle arcade as part of the nineteenth-century restoration. Whilst it is not included as part of the architect's works narrative, the upper masonry foundation was partially covered by a thin layer of broken red bricks upon which the carved moulded base of the pier respond was positioned. The inclusion of this brick layer clearly suggests that whilst the entire pier respond may not have been repositioned during the restoration, its base almost certainly had been reset.

Plate 9. Interior view of St Mary's Church, Frittenden in Area A showing the upper extent to the masonry foundation to the pier respond (*note: layer of broken bricks beneath the moulded pier respond base*).

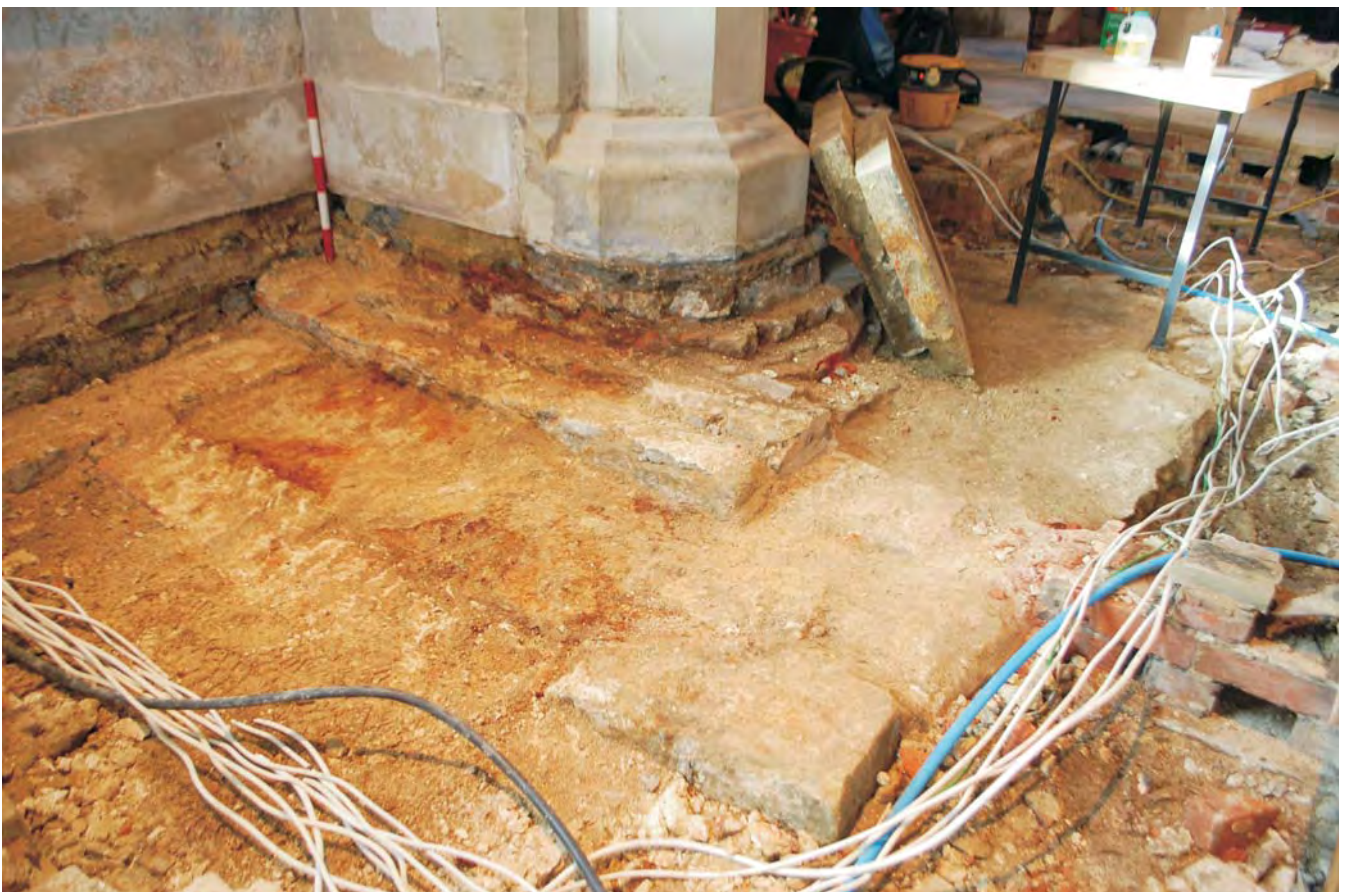
Plate 10. Interior view of St Mary's Church, Frittenden in Area A showing the upper extent to the masonry foundation to the pier respond following the removal of the brick dwarf walls (*note: hewn ashlar stone blocks forming the outer extent to the foundation*).

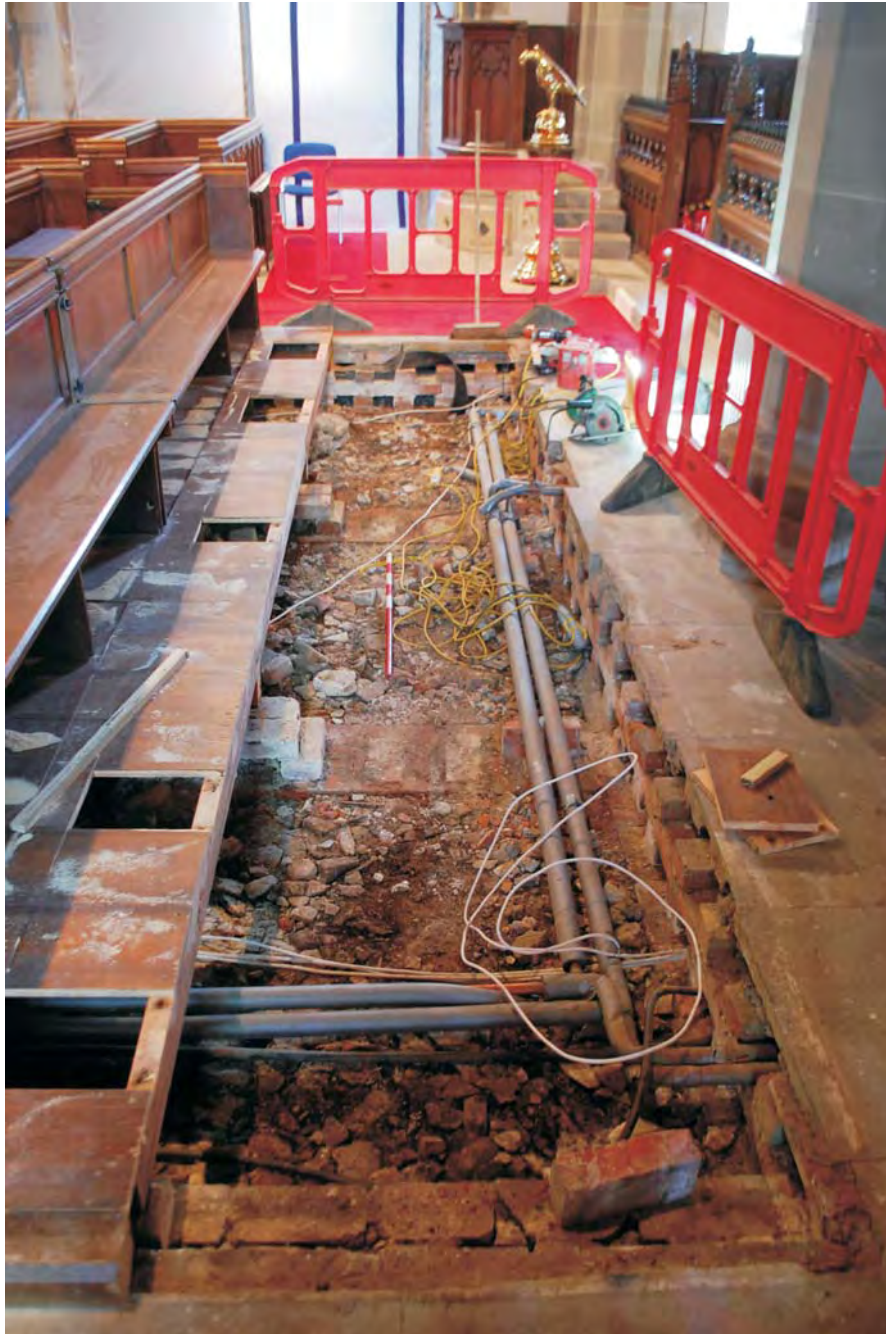
Aligned east – west along both the north and south sides of the entire reduced area with a north – south aligned return along the area’s eastern end were a series of brick dwarf walls to provide support to the ends of a sequence of perpendicular timber floor joist. Their centres being supported by two further parallel brick dwarf walls equidistant apart and aligned east – west through the centre of the air void. All the walls were formed of unfrosted red Kentish stock bricks bonded with a mortar like that noted covering the upper surface to the reduced area. Each wall consisted of three courses tall (240mm), and whilst the two central walls were one brick length wide (220mm), it is assumed the three outer walls were the same, but these were partially obscured by adjacent Yorkstone floor slabs forming the surrounding aisle walkways. As already noted in Area A, each of the supporting brick dwarf walls were constructed with a series of regularly spaced through-holes to aid in the circulation of air beneath the timber flooring. Sealing the thin mortar layer across the reduced surface was a roughly 60mm thick deposit of mid – dark greyish brown loose sandy, gritty soil and dust

containing numerous small pieces of discarded Ragstone chippings, broken lime mortar lumps and occasional broken ceramic roof tiles. This also included other more recent discarded material such as small timber off-cuts and clippings from electrical cables, presumably associated with the later installation of modern services?

Plate 11. Interior view of Area B in St Mary's Church, Frittenden showing brick dwarf walls to support timber pew floor and recent rubble infill.

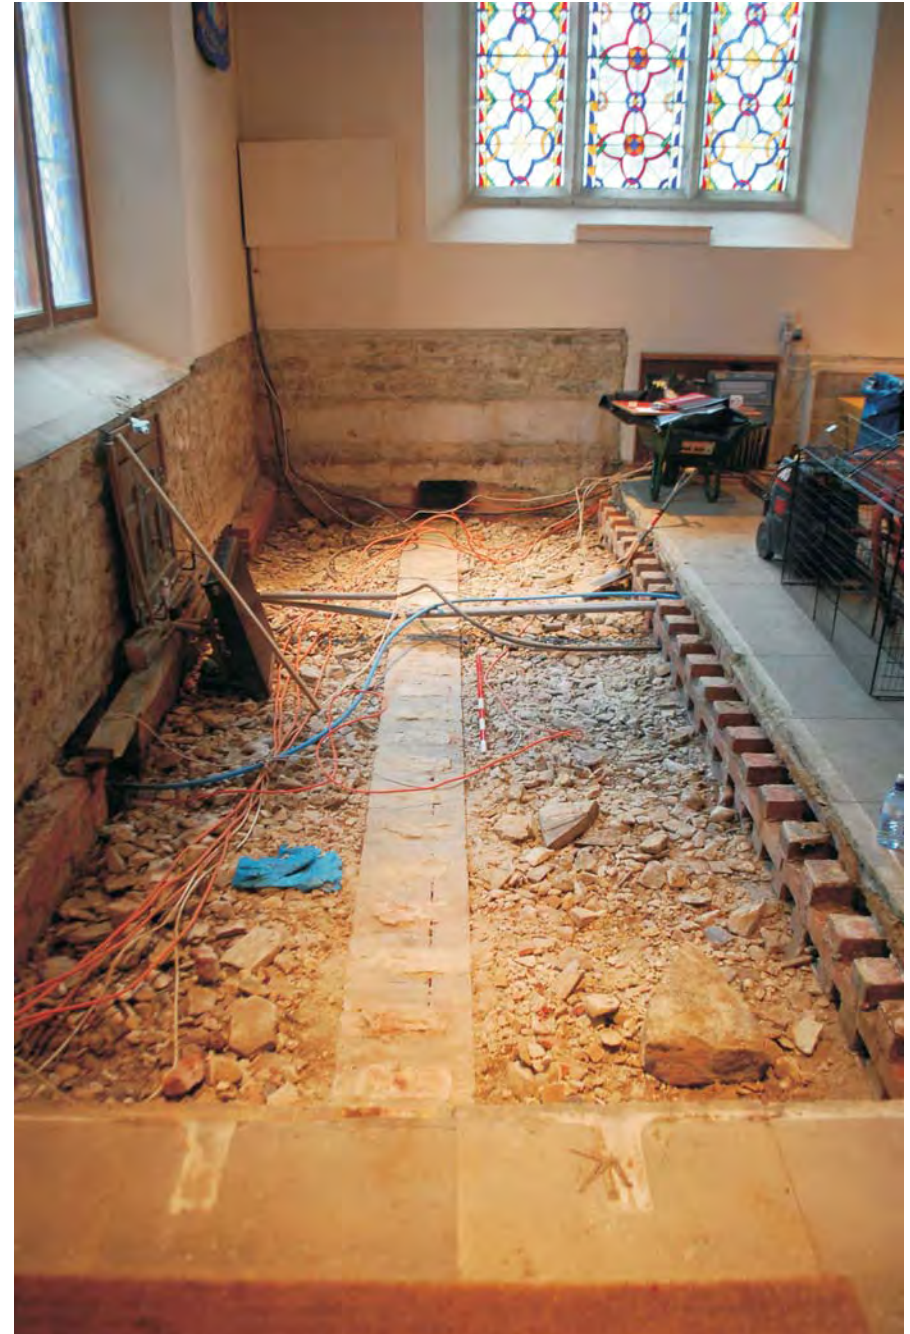
Extending along the area's northern side, on an east – west alignment, and across the eastern end on a north – south alignment, are two dwarf support walls formed of unfrogged Kentish red bricks bonded with mortar like that sealing the upper surface of the reduced area. Each wall segment consisting of only three brick courses tall (240mm) and is assumed their widths would correspond with those already encountered in Areas A and B and thus would be one brick length wide (220mm), however, the northern side to the north dwarf wall and the eastern side to the east dwarf wall were obscured by a series of square Yorkstone floor slabs forming the paved walkways to the south aisle. Aligned east – west through the centre of the exposed area was a further brick dwarf wall of similar construction to the north and east brick dwarf walls. As already noted in Area A and B, each of the supporting brick dwarf walls were constructed with a series of regularly spaced through-holes to aid in the circulation of air beneath the timber flooring. Clearly inserted to provide support to the centres of the perpendicular timber joist of the pew floor, it too was constructed with regular through-holes in its construction to allow air to pass beneath the two below floor areas formed by its insertion.

Sealing the thin mortar layer across the reduced surface was a roughly 60mm thick deposit of mid – dark greyish brown loose sandy, gritty soil and dust containing numerous small pieces of discarded Ragstone chippings, broken lime mortar lumps and occasional broken ceramic roof tiles. This also included other more recent discarded material such as small timber off-cuts and clippings from electrical cables, presumably associated with the later installation of modern services?

Plate 12. Interior view of Area C in St Mary's Church, Frittenden showing brick dwarf walls to support timber pew floor and recent rubble infill.

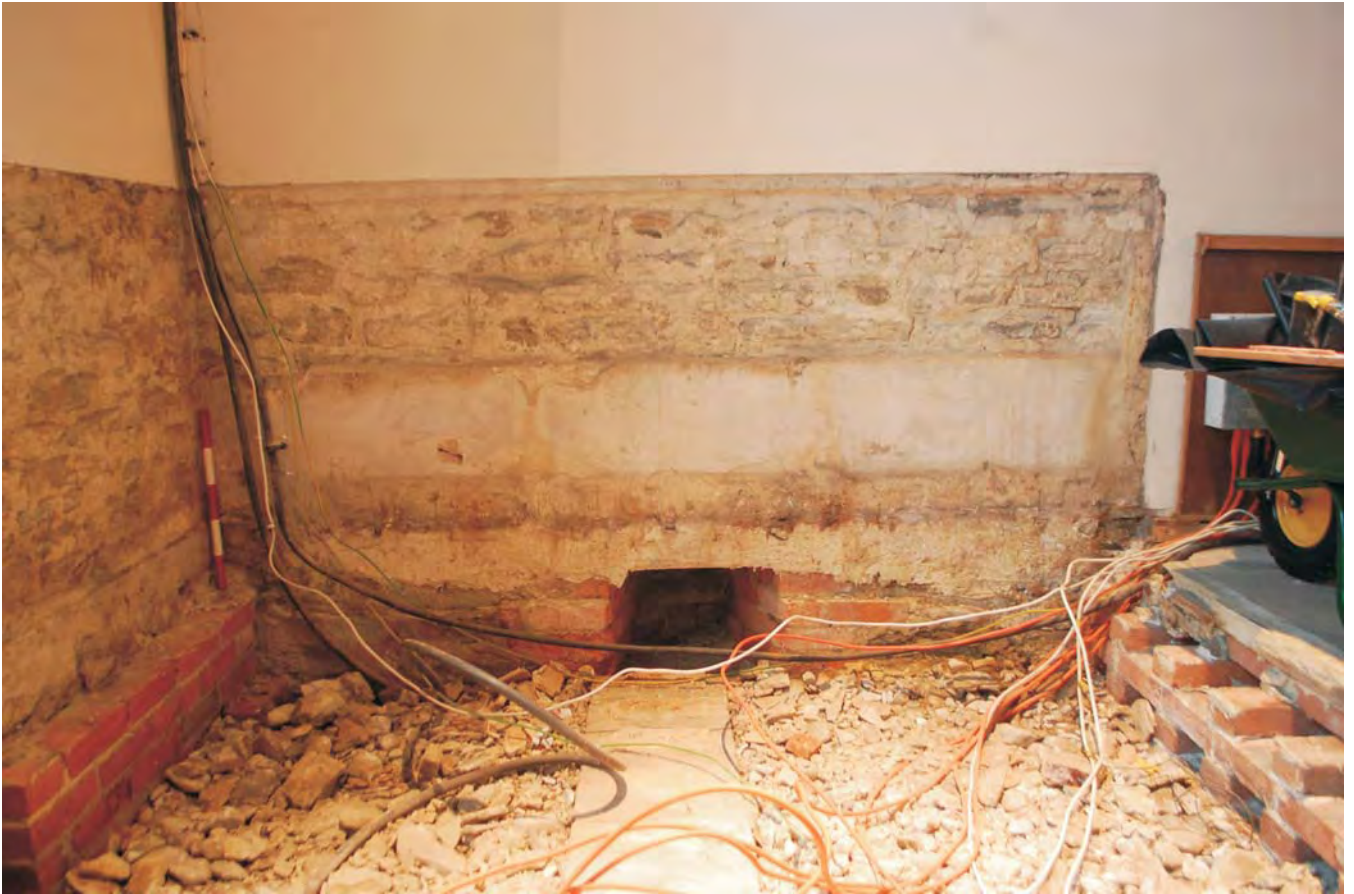
These dwarf walls contrasted with the supporting dwarf brick walling formed against the inner face to the south aisle's south wall, which consisted of three courses of a single skin of similar bricks bonded with the same lime mortar as noted elsewhere. Unlike the dwarf brick wall along the north side of the area, there was no need for the regular series of through-holes for ventilation, but instead a pair of rough square openings were formed through the thickness of the south aisle's south wall and a vented opening created within the aisle wall's exterior face. A similar opening was also noted extending through the lower portion of the south aisle's west wall, but here there was no brick dwarf wall along the wall's interior face, instead the wall possessed a stepped foundation along its exposed base projecting roughly 100mm from the main wall face. Either side of all three opening, which were clearly to enable fresh air to pass beneath the timber floors through the width of aisle's outer walls, was a lining of

red brickwork and bonding mortar similar to that used in the dwarf walling, and clearly indication they are of a similar phase of construction.

Plate 13. Interior view of Area C in St Mary's Church, Frittenden looking west showing the air vent opening through the base of the south aisle's west wall.

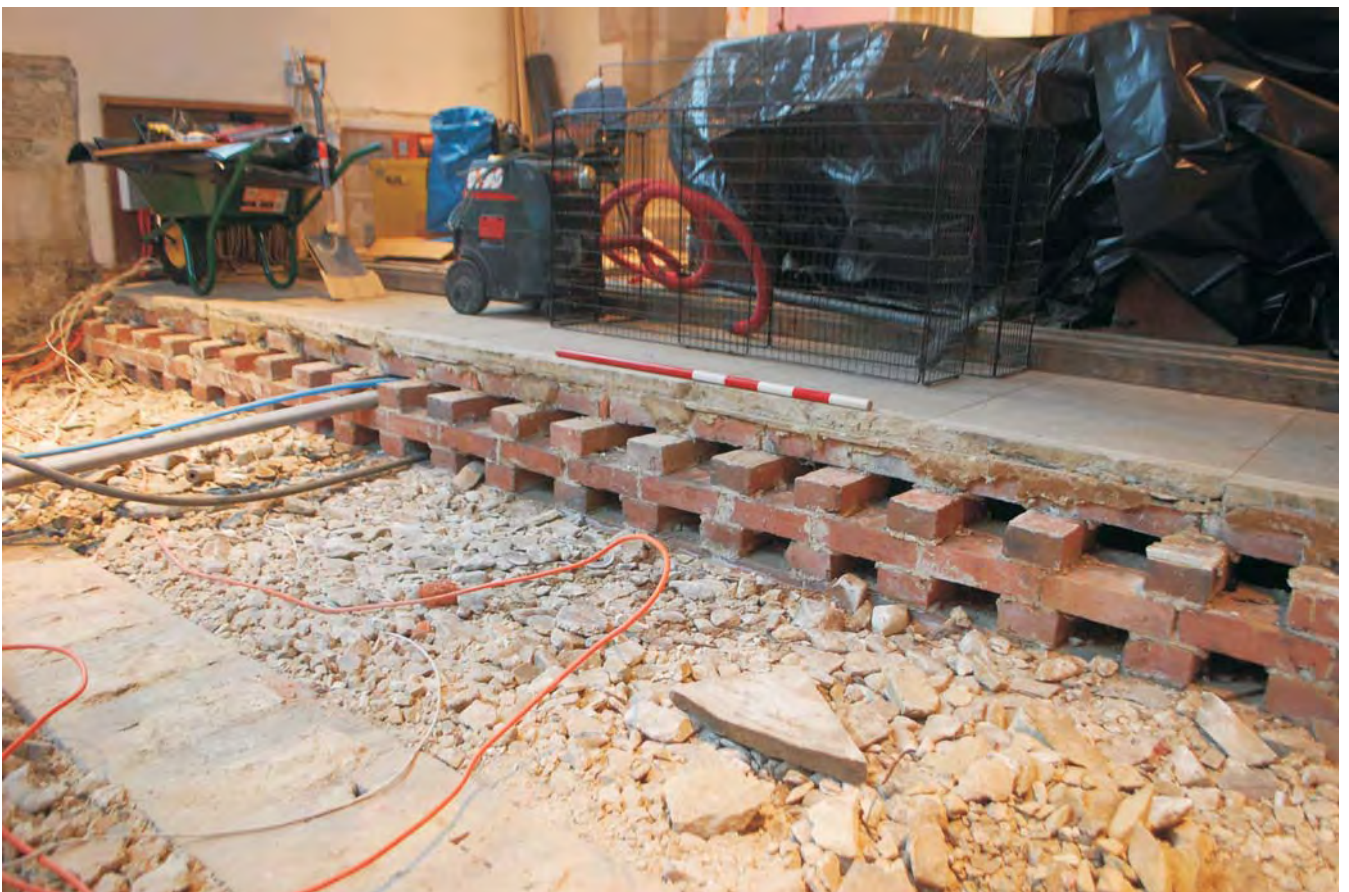
Plate 14. Interior view of Area C in St Mary's Church, Frittenden looking northwest showing through holes in the brick dwarf walls supporting the timber pew floors to aid in ventilation.

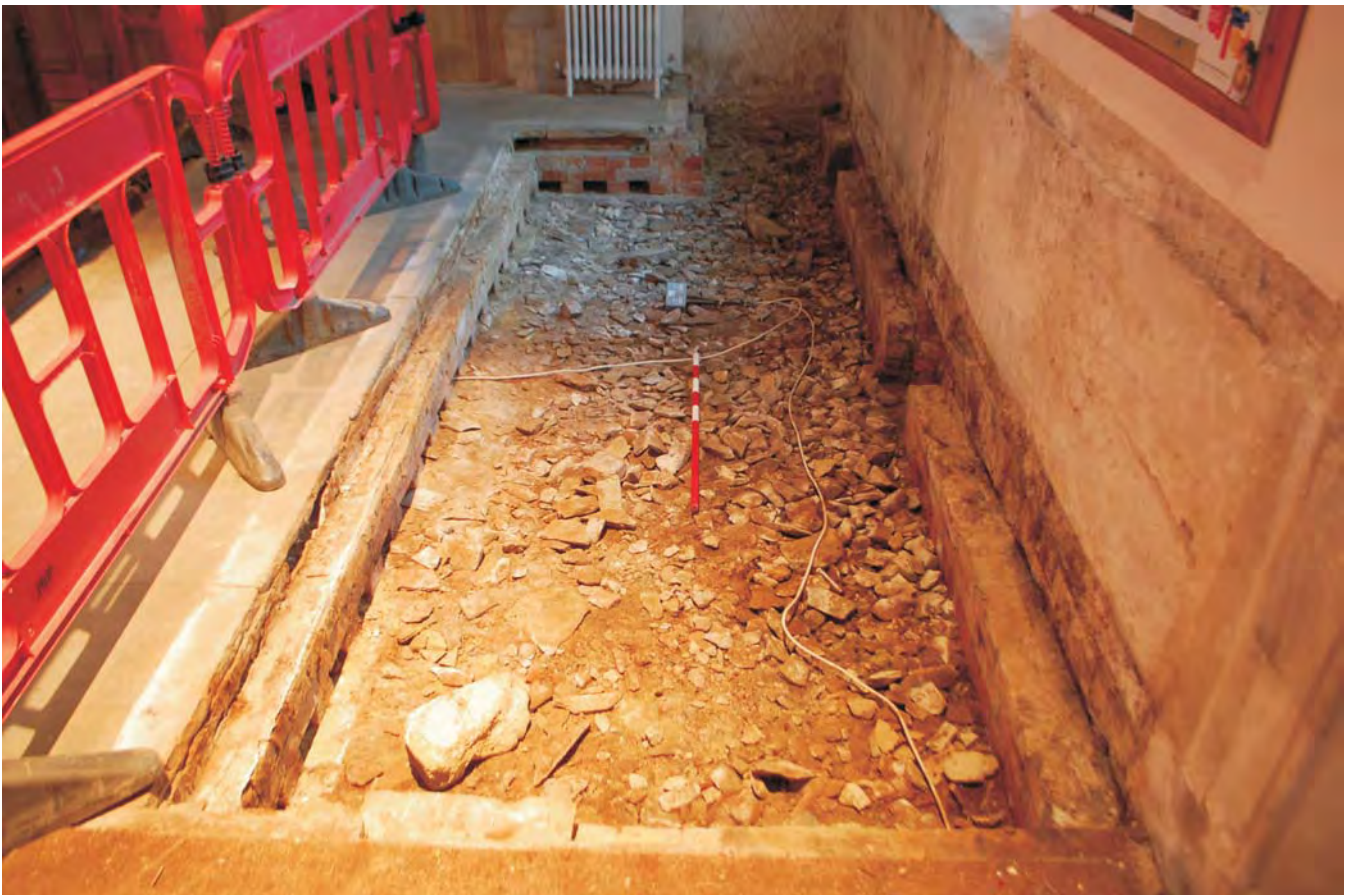
Due to the reduced width of this area, a red brick dwarf wall was constructed east – west along the area's northern edge with a short north – south length along its western end as well as forming the east and north sides of the projecting spur area. Formed of unfrogged Kentish red bricks bonded with mortar, similar to that sealing the upper surface of the reduced area, each wall segment consisting of only three brick courses tall (240mm) and is assumed their widths would correspond with those already encountered in Areas A, B and C thus would be one brick length wide (220mm). However, the northern side to the northern dwarf wall and the western side of the west end dwarf wall and those of the spur projecting area were obscured by a series of square Yorkstone floor slabs forming the paved walkways to the south aisle.

As already noted in Area A, B and C, each of the supporting brick dwarf walls were constructed with a series of regularly spaced through-holes to aid in the circulation of air beneath the timber flooring. However, unlike the other previously inspected floor areas, no evidence of central supporting walls was observed suggesting that due to the reduced width of this area, none were required.

Plate 15. Interior view of Area D in St Mary's Church, Frittenden looking east showing brick dwarf walls to support timber pew floor and recent rubble infill (*note: small projecting spur area beside the radiator*).

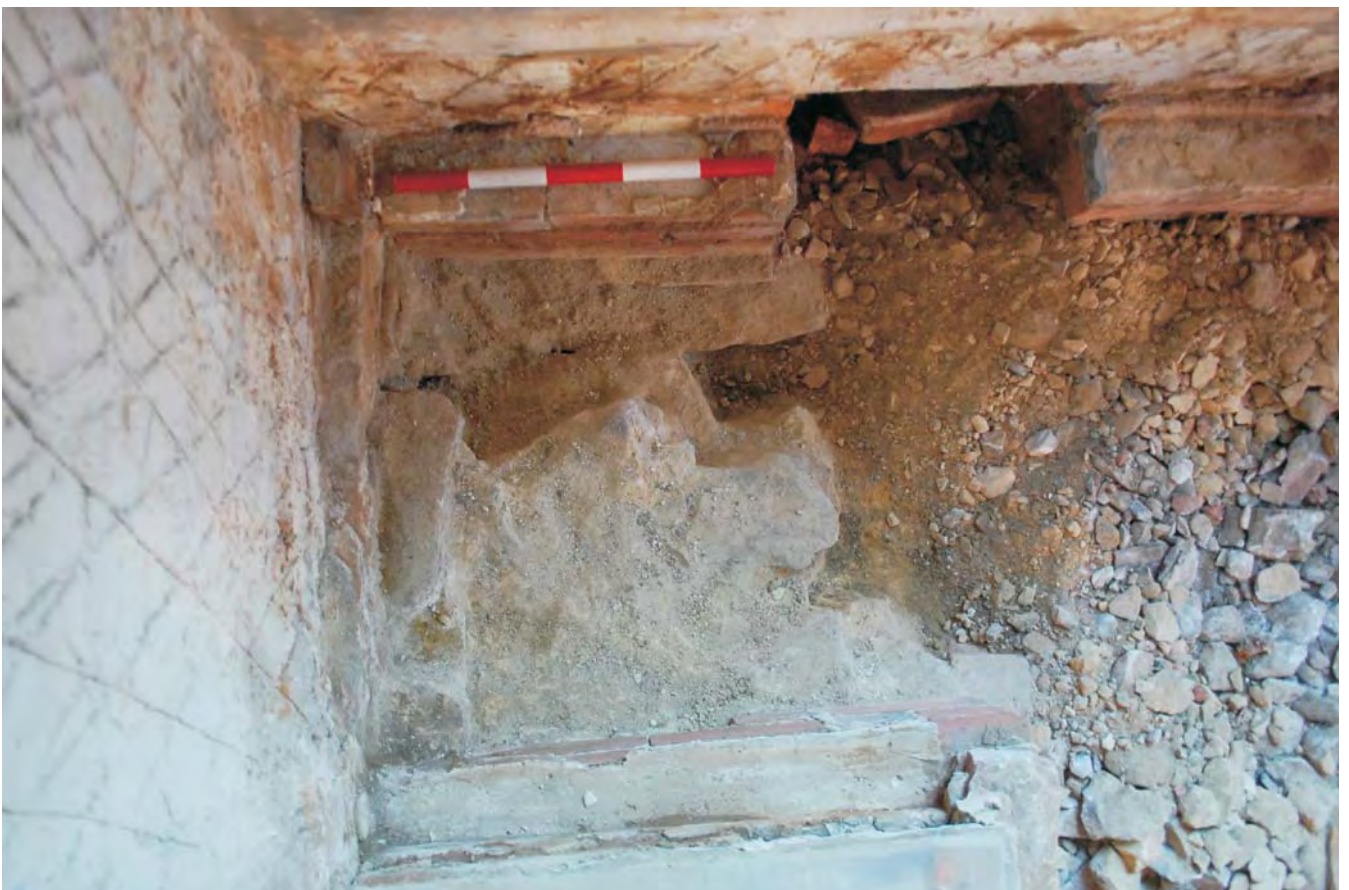
The earliest deposit exposed across this area consisted of the upper extent to a small – moderate sized portion of masonry foundation extending across most of the small projecting part of the removed floor area. Covering an area of approximately 740mm square, the foundation was composed of small – medium irregular pieces of Ragstone rubble bonded with coarse gritty pale creamy grey lime mortar containing small angular flint and Ragstone inclusions throughout. With a roughly level upper surface approximately 320mm below the former timber floor level, it's outer limits were abruptly defined by a ragged edge of cut-back masonry suggesting it had been cut into, possibly during the formation of the reduced floor area as part of the nineteenth-century restoration.

Examination of the junction between this foundation and the interior face of the south aisle's east wall revealed it predated the aisle wall, which appeared to have utilised the earlier masonry as a foundation and had been bonded to its upper surface. Along the foundation's southern extent, the present south wall of the south aisle appears to have extended below the present reduced floor surface suggesting either the earlier foundation had been partially removed, or that that this represented the southern extent of the foundation? Examination of a suggested phase plan of the church shows this earlier foundation may represent the foundations to a projecting buttress extending southwards from the earlier medieval south aisle's southeast corner? If correct, this would suggest the foundation would date to the Early English period (AD1180 – 1280), however, it is known that the construction of the south chapel would have affected the eastern end wall to this earlier south aisle. If so, the foundation may relate to the reconstruction of the buttress in the Early Decorated period (AD

1280 – 1330) when the formation of an opening through the aisle's east wall may have necessitated the need to rebuild the buttress?

Plate 16. Detail view of the projecting part of Area D in St Mary's Church, Frittenden showing the masonry foundation to a possible earlier buttress within the small projecting area.

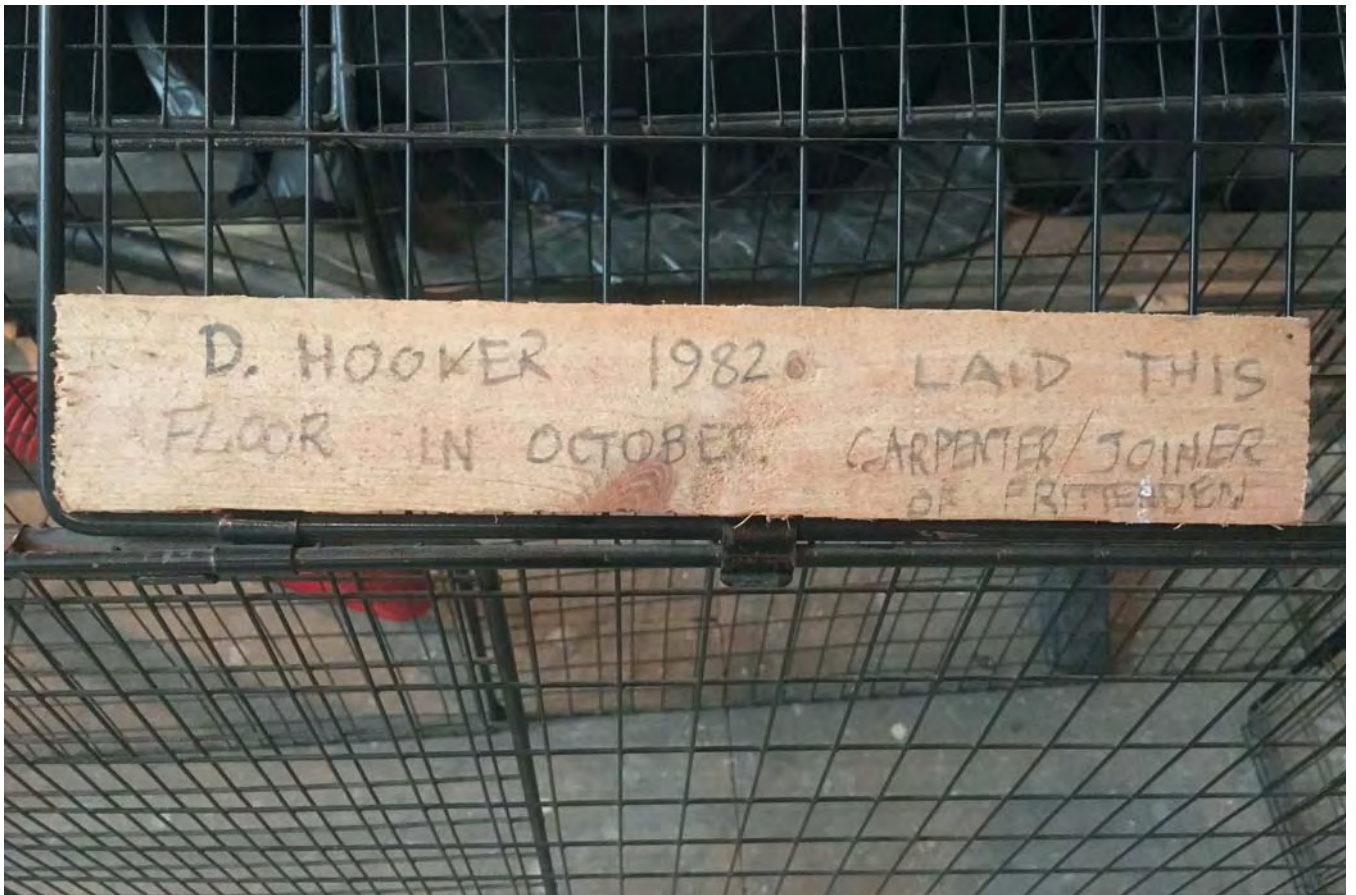
One such piece of discarded timber from beneath the present floor was noted as being inscribed in pencil with ‘D. HOOKER 1982 LAID THIS FLOOR IN OCTOBER. CARPENTER/JOINER OF FRITTENDEN’. Clearly a local man proud of his achievement?

Plate 17. Image of a small timber off-cut discarded beneath the pew floor with inscription.

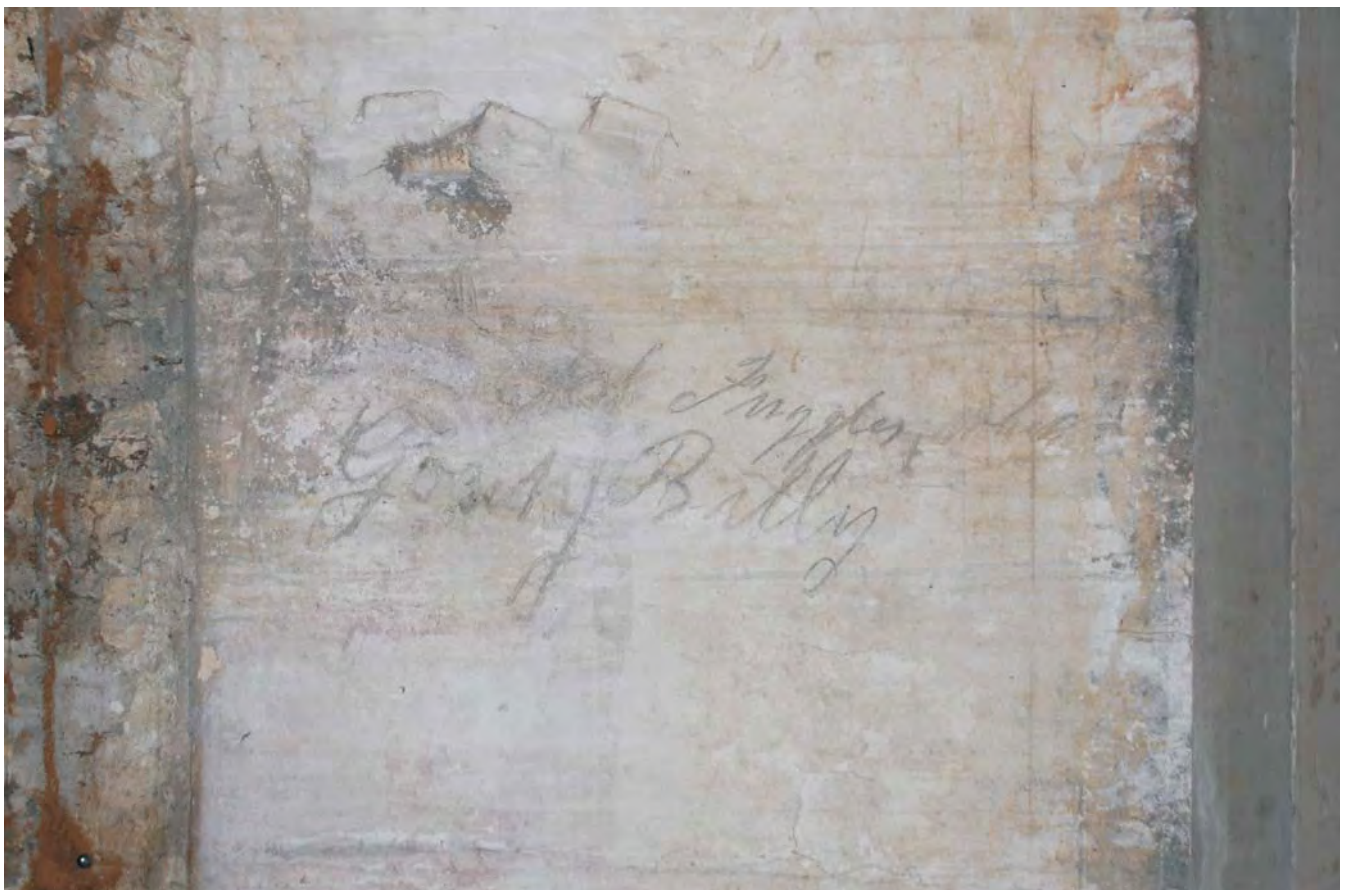
Whilst the sections of dwarf brick walling along the north side of the area and the base of the aisle south wall were clearly intended to provide end support to the perpendicular joists, these were covered with a nailed timber boarded floor into which the pew benches were jointed into its upper surface. As part of the pew seating installation, sections of wainscot panelling were attached to the internal face of the aisle's south and east walls. Removal of this panelling as part of the present alterations revealed a continuation of the internal plaster face to the aisle's walls. Inspection of its surface revealed a small inscription incised into the surface of the plaster prior to it setting. Written in a florid 'copper-plate' script, it appears to be a semi-insulting text saying *'Ask Inggles who is Gouty Billy'* and probably relates to

jocular play between the workmen engaged in the restoration of the church in the mid nineteenth-century, there is the possibility of it relating to an earlier parody linked with the former prime minister William Pitt (the younger), who was known to have suffered with gout. Unfortunately, these earlier events occurred over forty years previous to the restoration of the church and seem unlikely?

Plate 18. Image of concealed inscription incised into plaster face of the south aisle's south wall.
