# St Mary's Church, The Street, Frittenden, Kent.

## Archaeological Watching Brief Summary Report

Project Code: WB SMCF17  
Planning Ref: N/A  
NGR: TQ 81319 40944 (centred)  
CAT Ref: 4174

August 2018

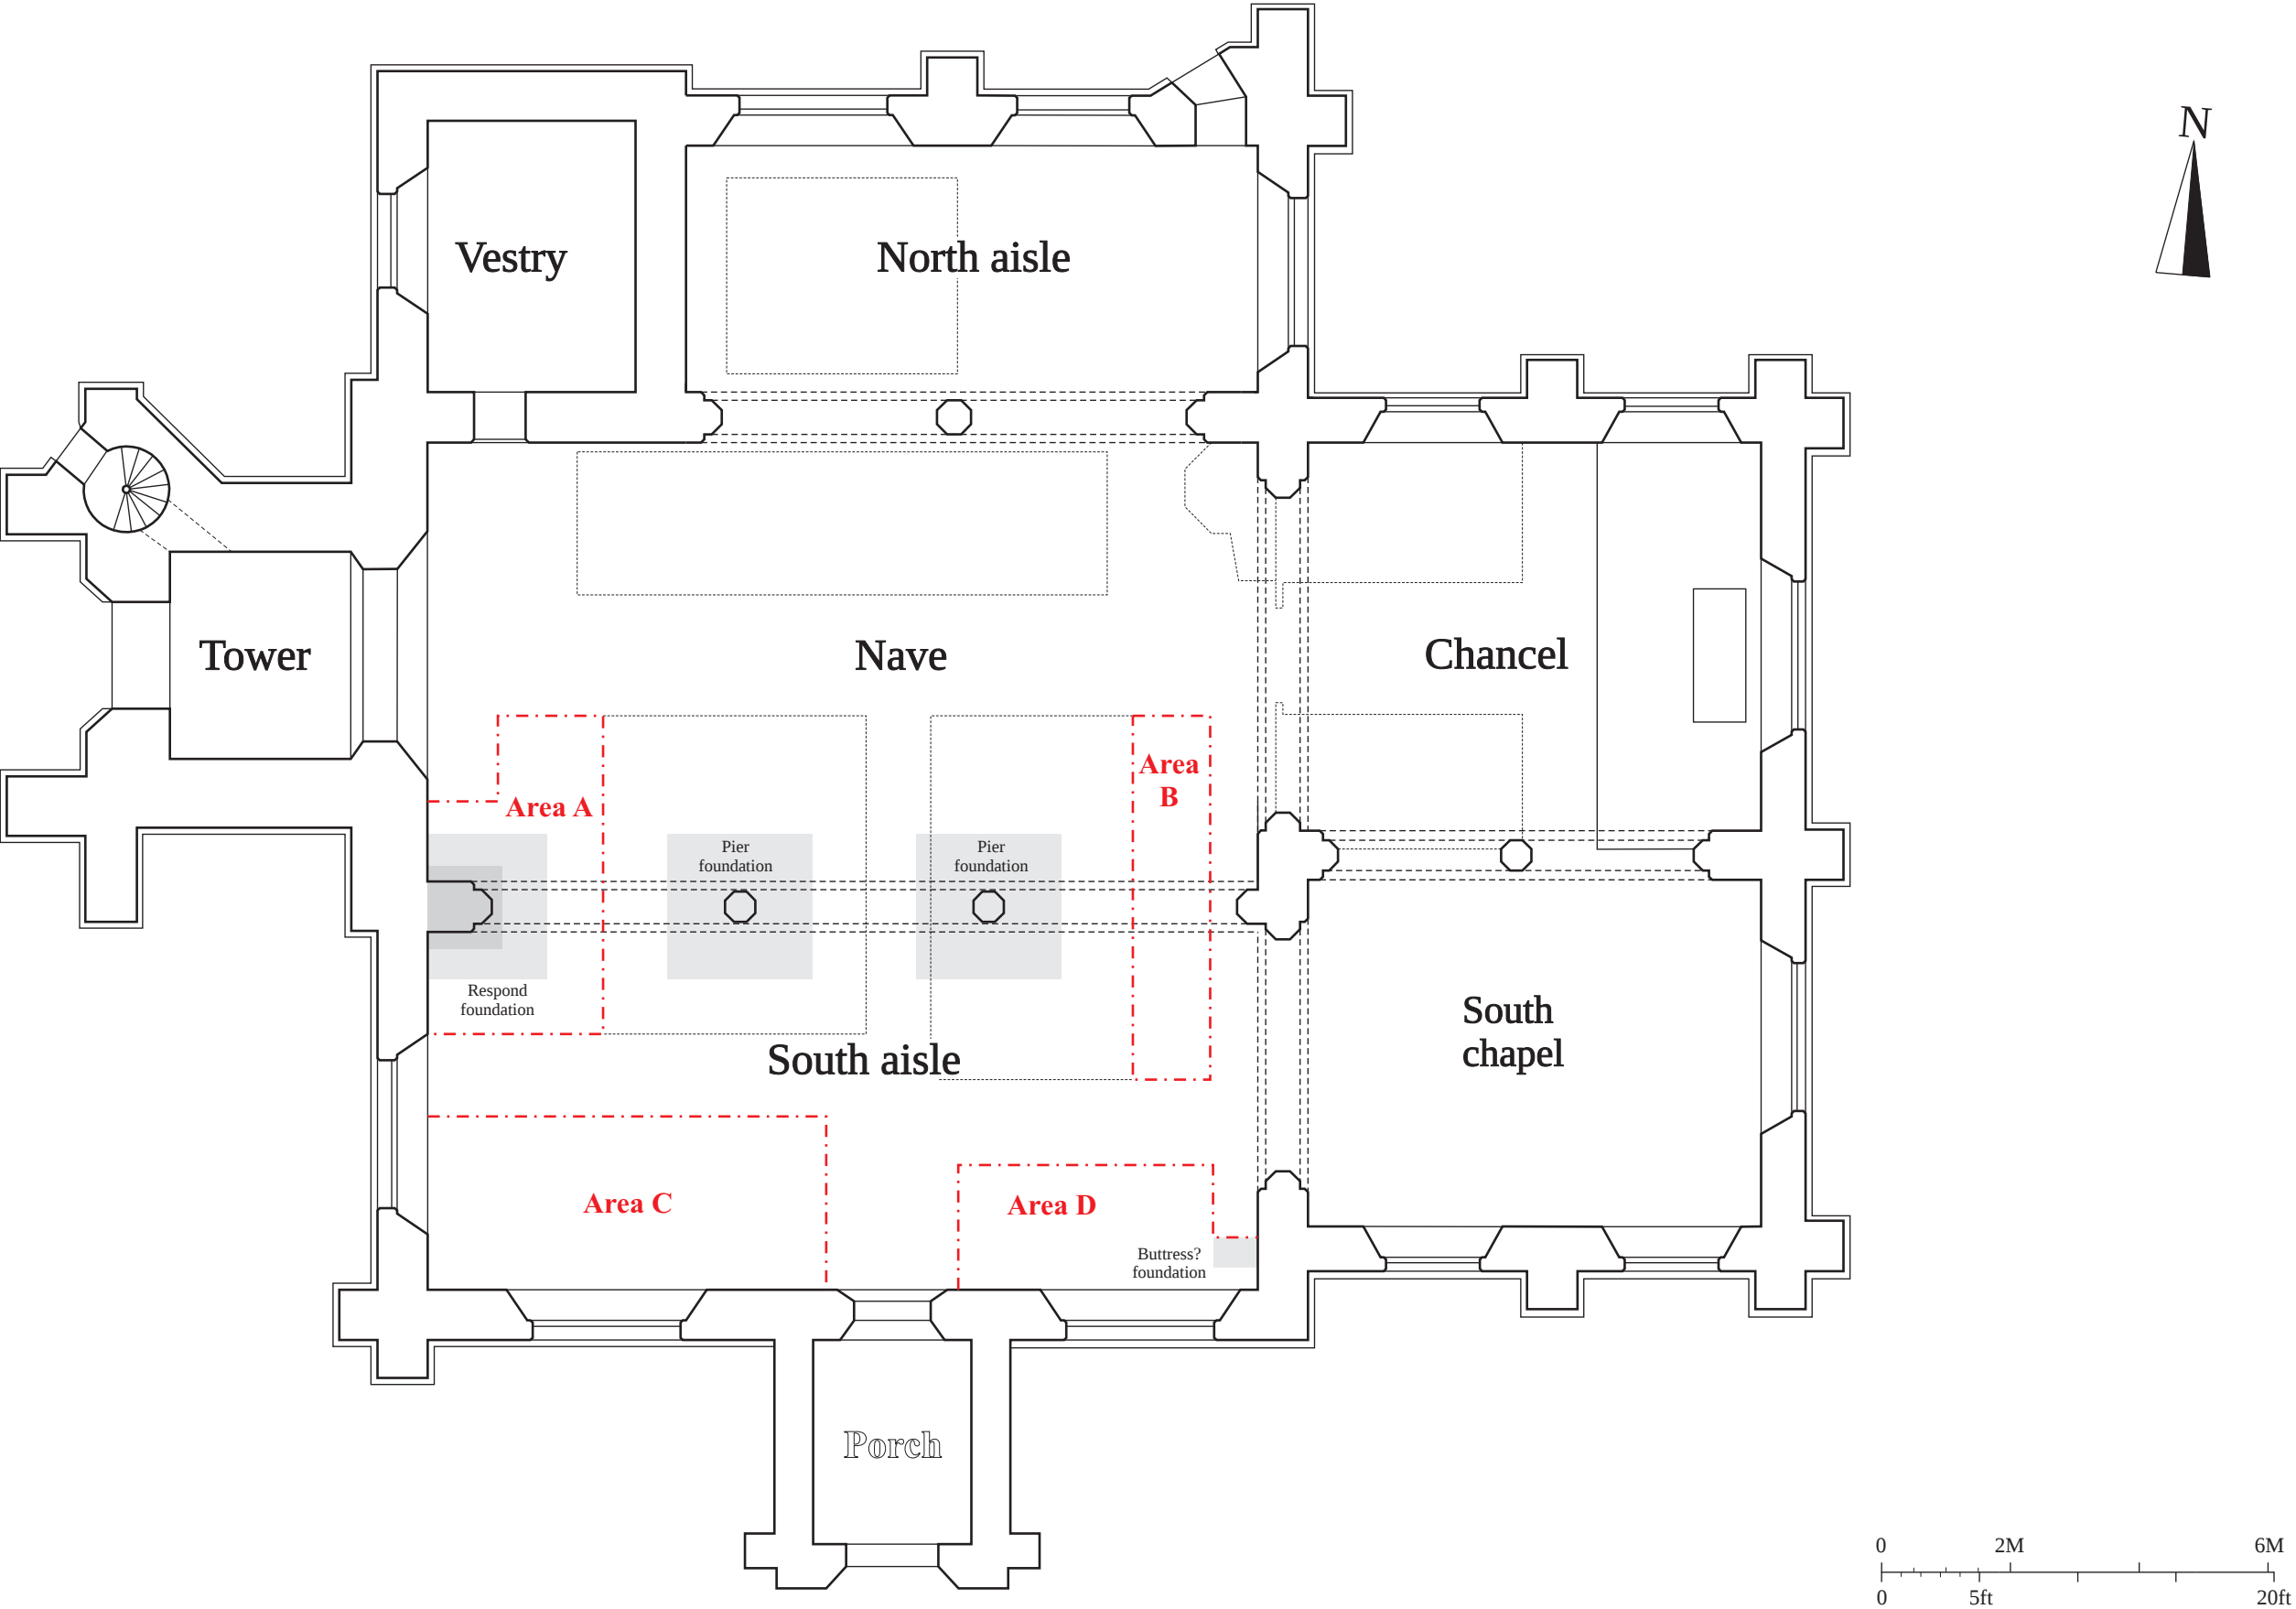
Figure 2. Plan of St Mary's Church, Frittenden showing the areas of pews and timber flooring (Areas A - D) removed and archaeologically inspected.

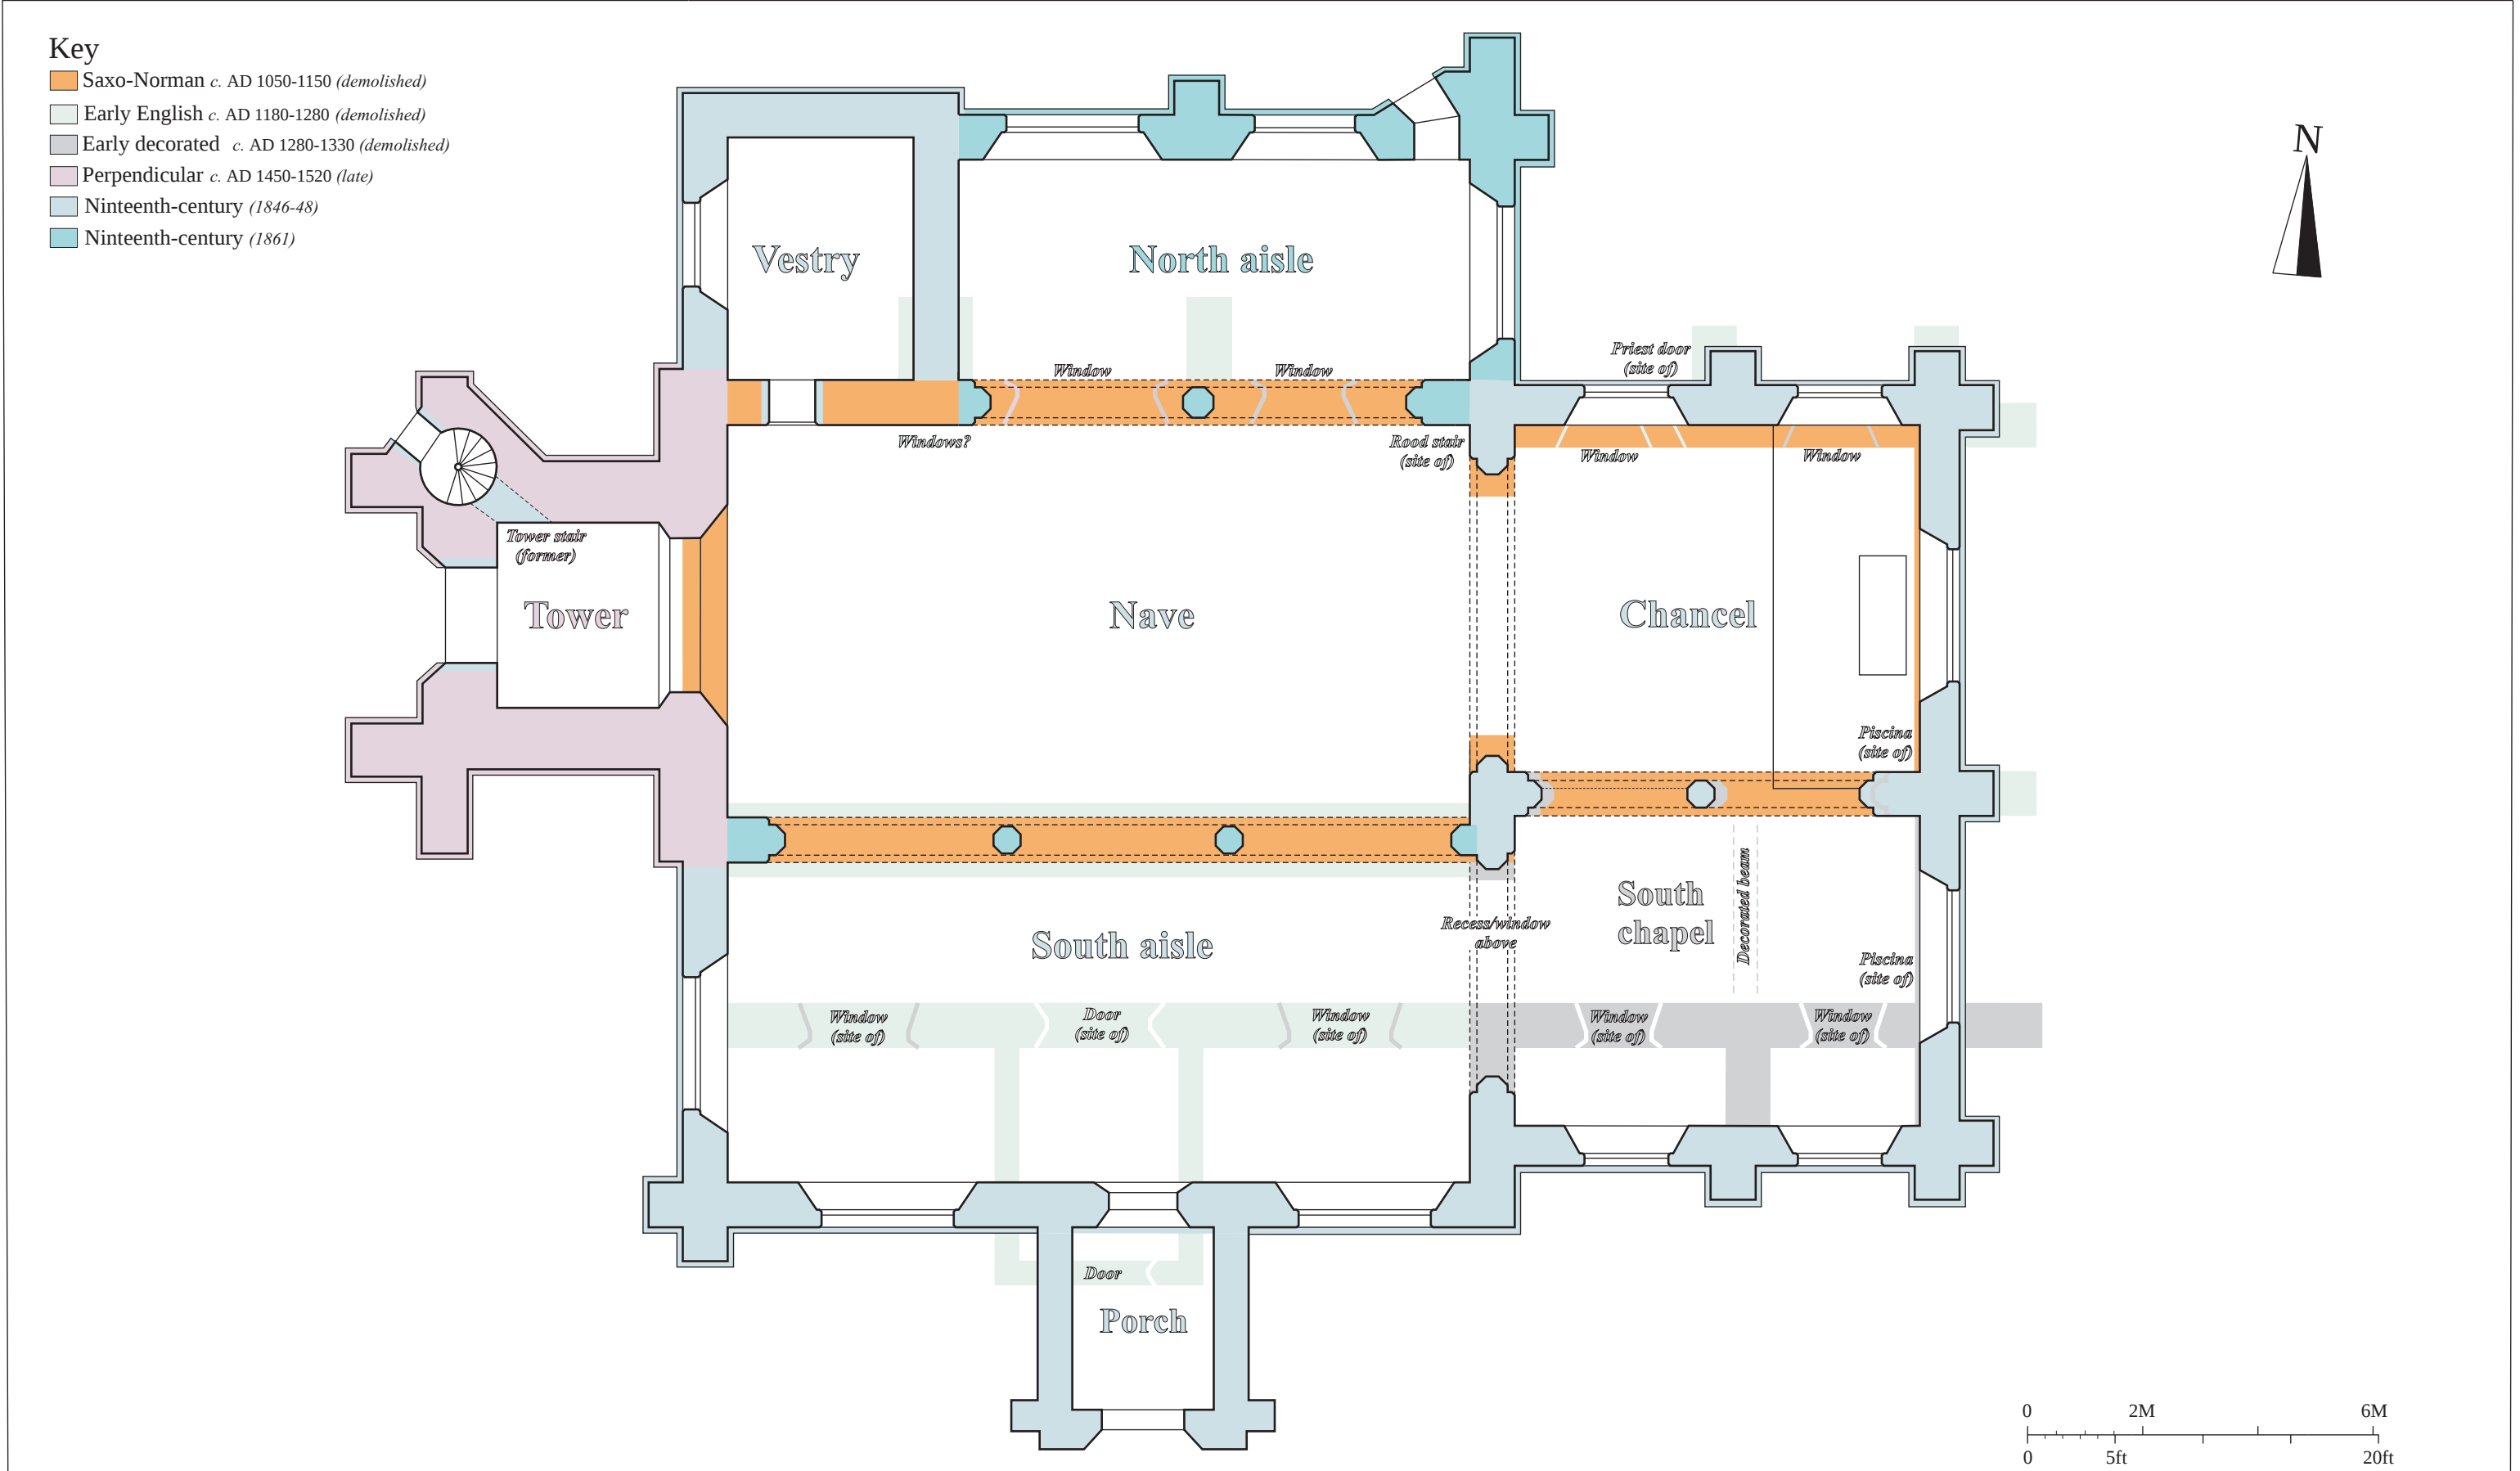
Figure 3. Plan of St Mary's Church, Frittenden showing suggested main phases of its development achieved by pre-restoration illustrations and architect's (R.C. Hussey) working text of 1849.

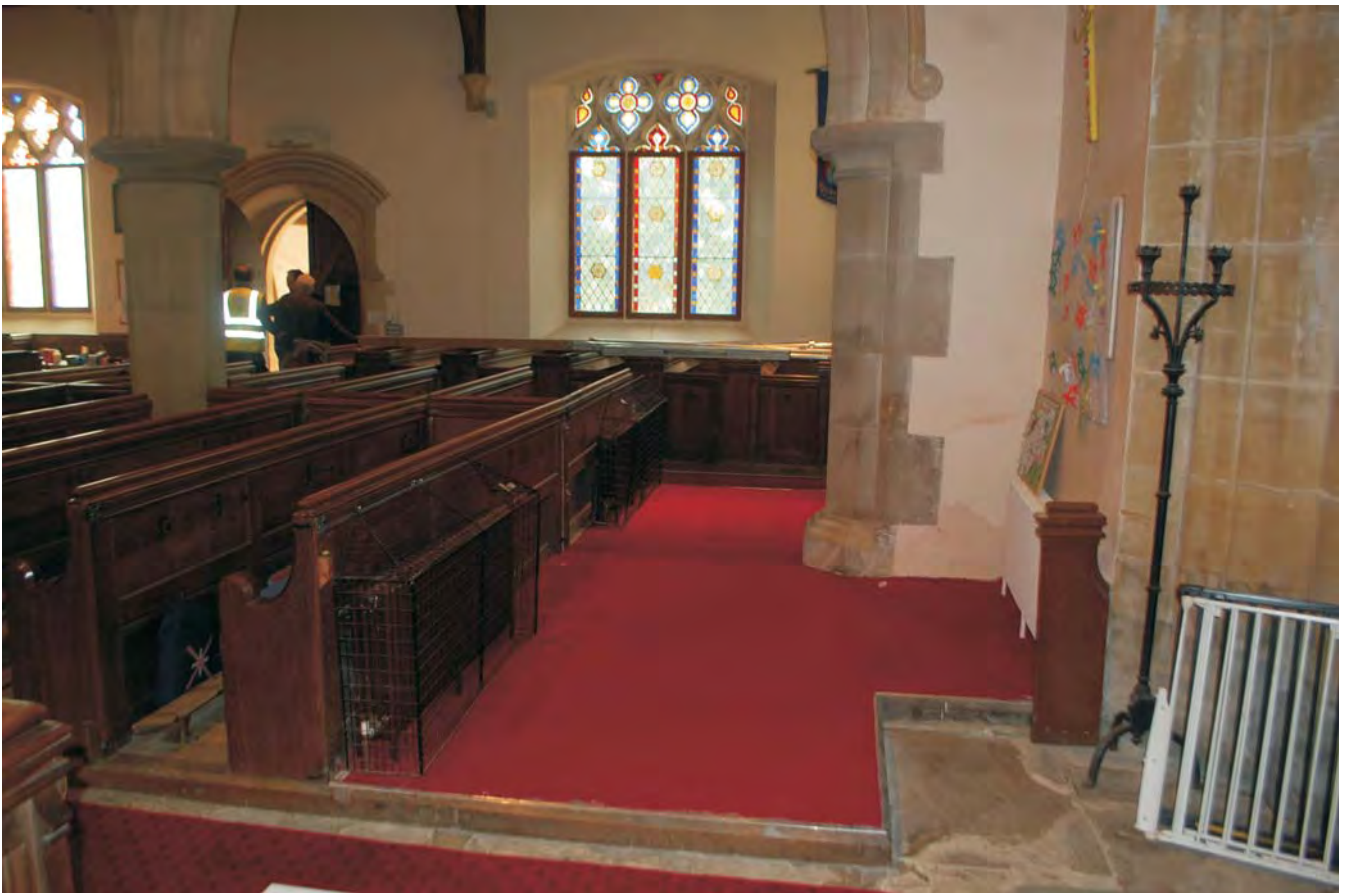
Plate 3. Interior view of St Mary's Church, Frittenden looking south across Area A prior to removing the pews and timber flooring.

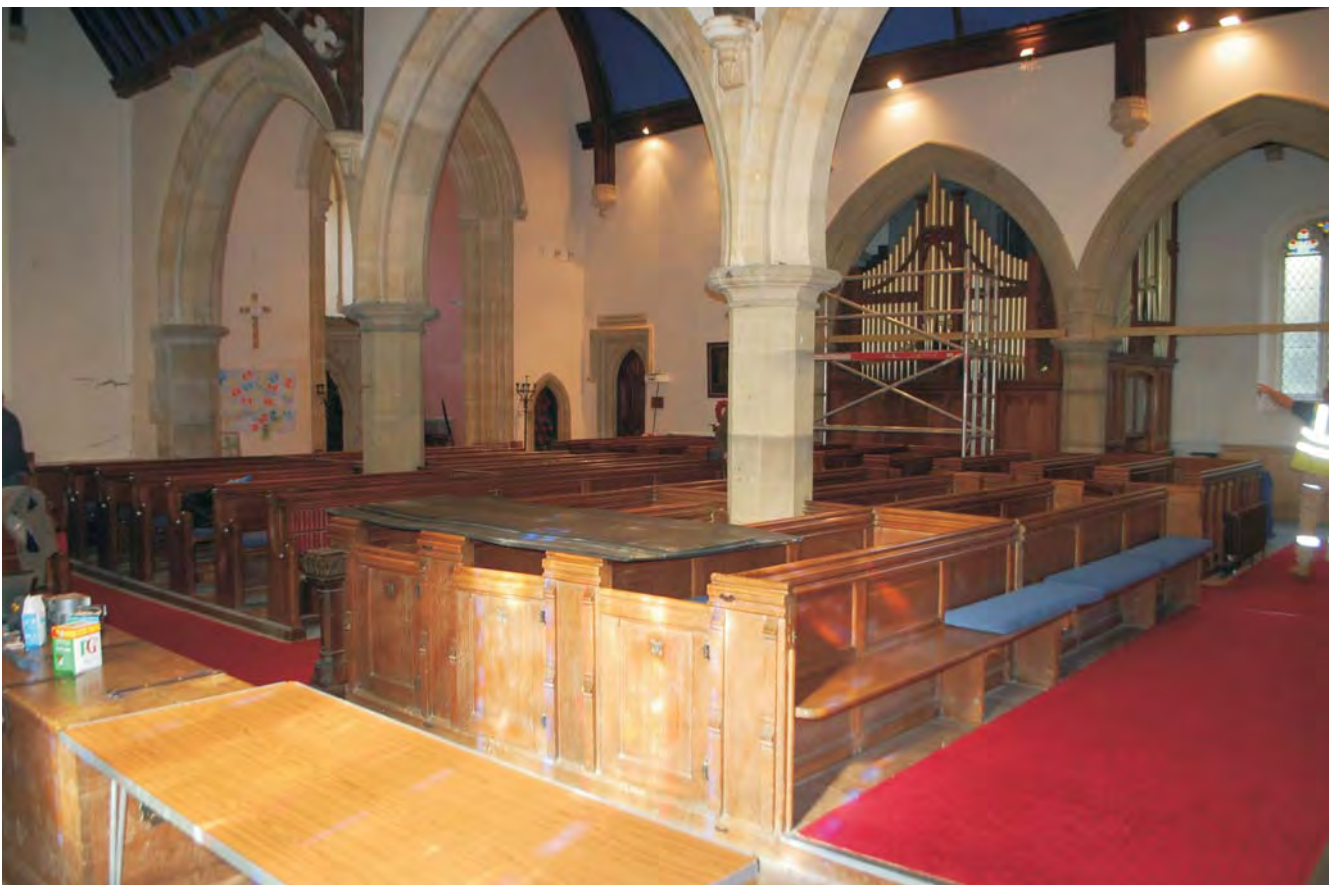
Plate 4. Interior view of St Mary's Church, Frittenden looking northwest across Area B prior to removing the pews and timber flooring.

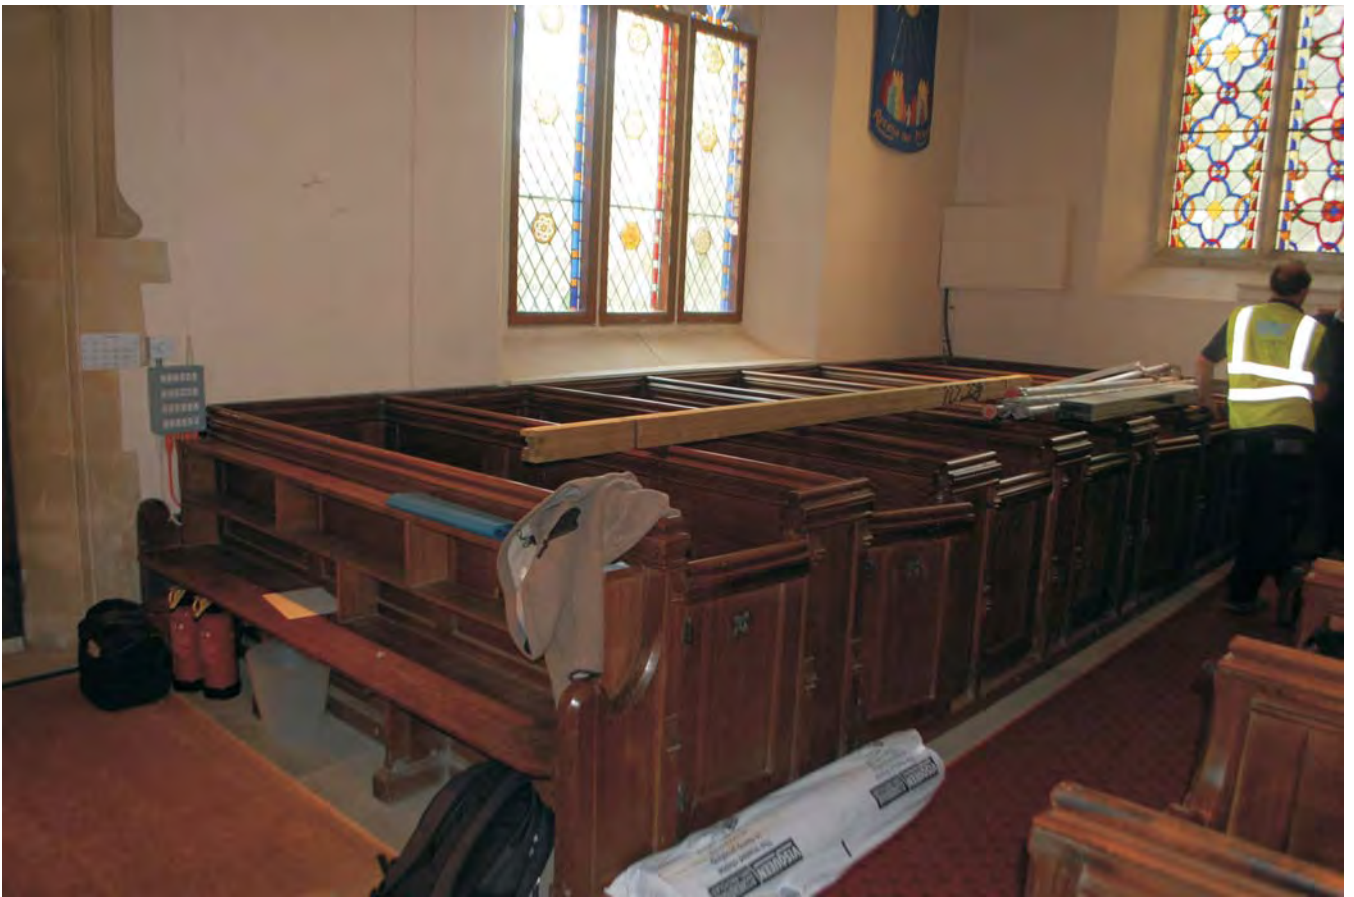
Plate 5. Interior view of St Mary's Church, Frittenden looking southwest across Area C prior to removing the pews and timber flooring.

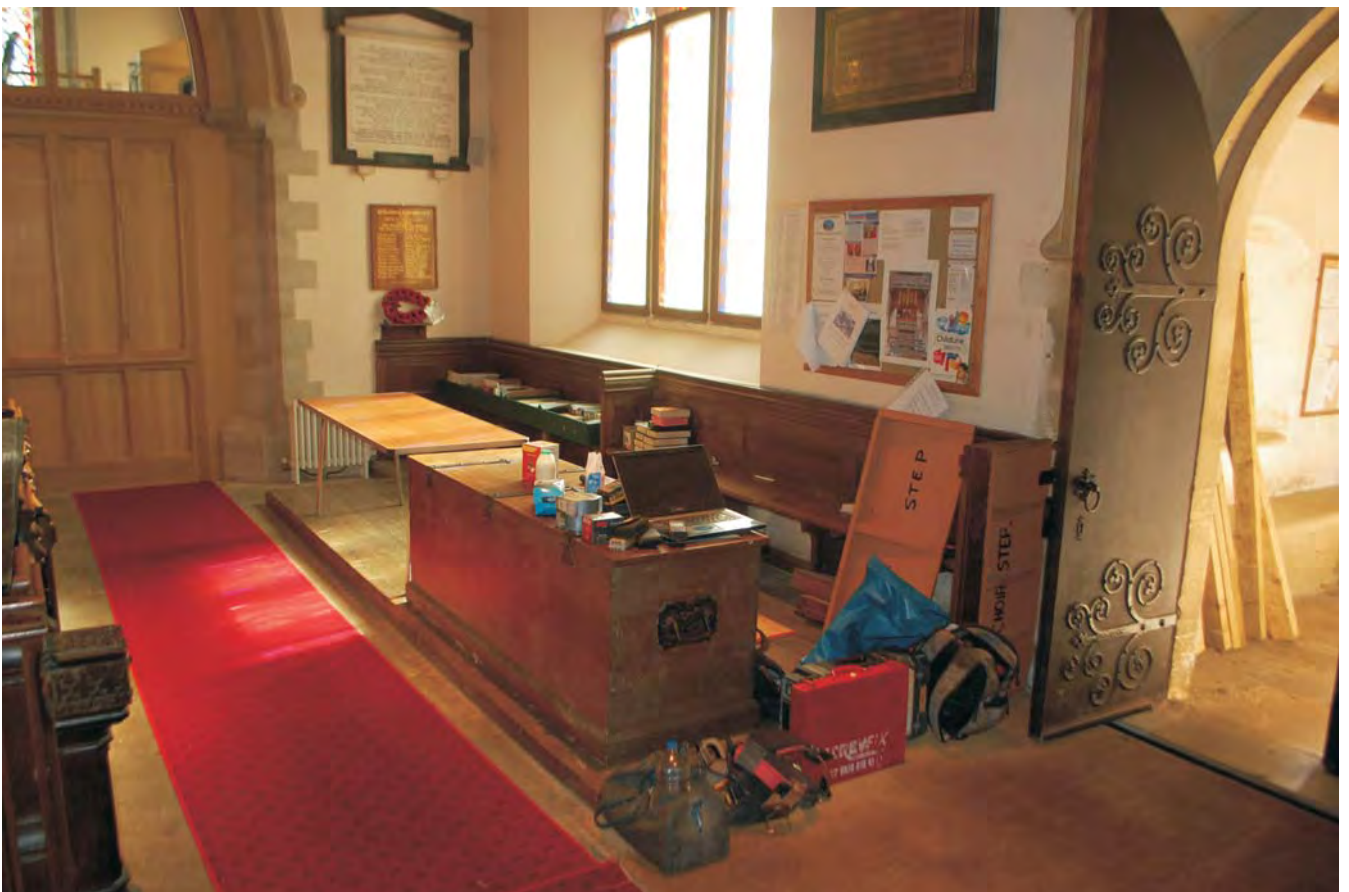
Plate 6. Interior view of St Mary's Church, Frittenden looking southeast across Area D prior to removing the pews and timber flooring.
